Project Summary

US Army Engineer
Research and Development Center
Waterways Experiment Station

April 2000

Factors Contributing to Louisiana Levee Failure

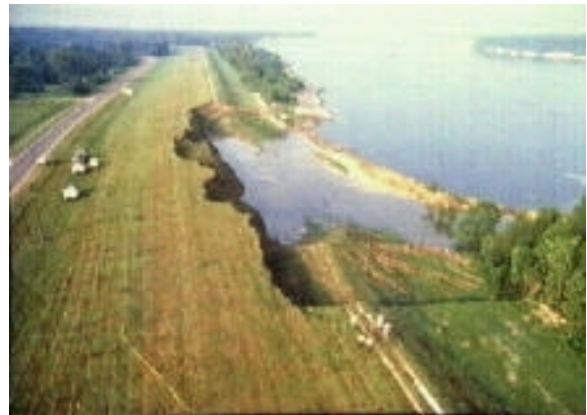
A section of levee along the Mississippi River near Marrero, Louisiana, failed in a non-flood-related event and involved replacing nearly 230,000 cu m of riverbank and levee. The data examined during research on the causes of levee failure included geologic setting, historic bank migration and previous bank lines, thalweg profiles, width/depth ratios, scour pool movement, and river profiles. The geology within the pertinent river reach and Holocene chronology of changes in the river channel profile were critically important factors in revealing the cause of levee failure. The Marrero or Celotex failure occurred within sandy point-bar deposits from a former distributary channel of the St. Bernard delta system. During historic time, the river channel narrowed appreciably in the failure reach, while maintaining a near-constant cross-sectional area. The general failure mechanism involved scouring and erosion of sand from the toe of the river bank, causing an over-steepened slope and resultant instability of the upper bank. That is, severe scour at the toe resulted as the thalweg deepened through the sandy substratum. Flow failure in the sands then led to loss of the upper bank or batture. Thus the location of the failure was controlled by the nature of the geologic deposits beneath the levee combined with progressive deepening of river channel at this location.
